Manhole Inspection Summary

Manhole # S23I__012MH

Insp Date: **6/5/08 12:52 PM**

Location Address: **1435 Lemmon St**

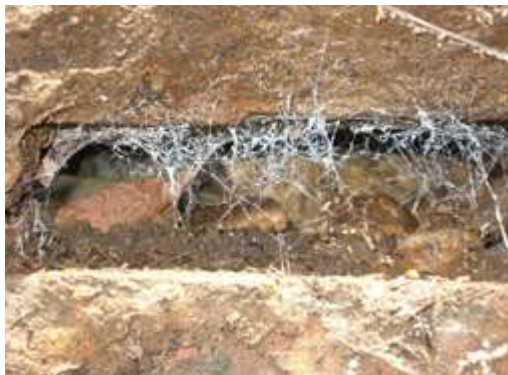
Defect 5

Condition: ☐ Sound ☐ Cracked ☐ Root Intrusion ☒ **Loose Brick** ☒ **Deteriorated**

missing bricks in chimney, deteriorated chimney

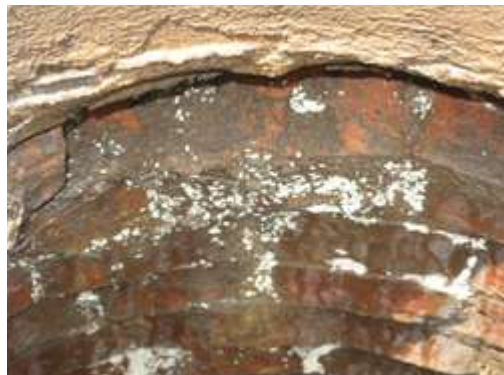
Defect 4

Infiltration: ☐ None ☒ **Joint** ☐ Cracks ☒ **Mortar** ☐ Roots ☐ Wall

infiltration frame chimney

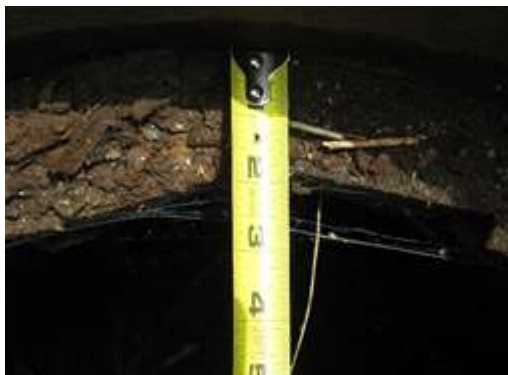
Defect 6

Offset: **1.** (in.)
75

frame offset 1.75"

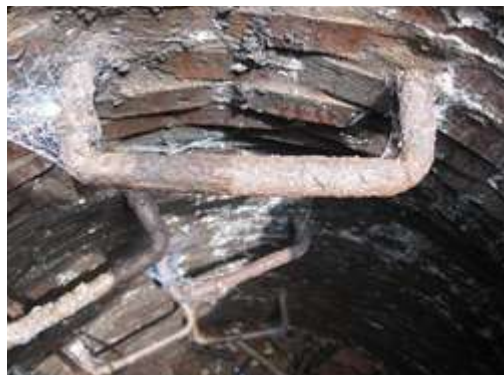
Defect 3

Count: **5** Missing: **0** ☒ **Corroded**

corroded rungs

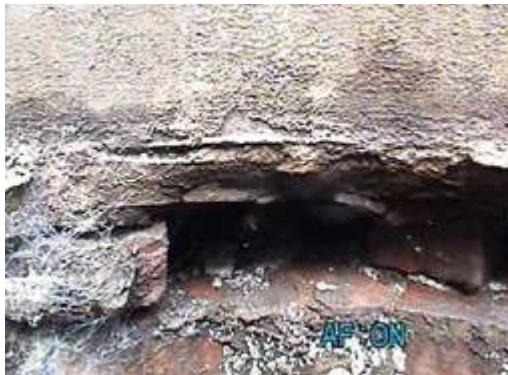
Defect 2

Condition: ☐ Sound ☐ Cracked ☒ **Leaks**

missing mortar, infiltration from frame-lid , frame chimney joint

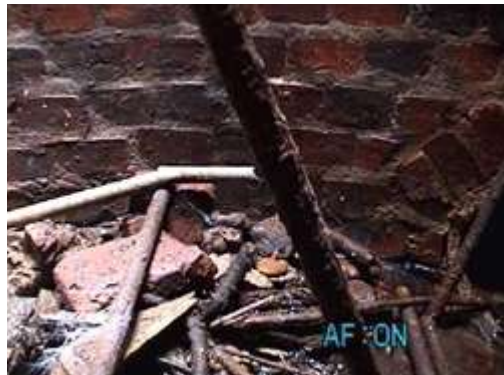
Defect 1

Condition: ☐ Sound ☐ Cracked ☐ Root Intrusion ☐ Deteriorated ☐ Leaks ☒ **Debris**

debris on bench
